Manhole Inspection Summary

Manhole # S23II_039MH

Insp Date: **9/29/07 9:26 AM**

Location Address: **518 SANFORD PL**

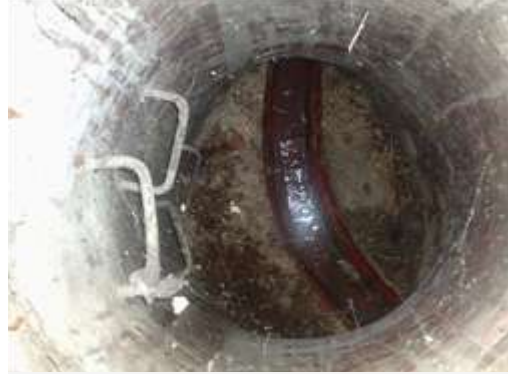
Top View

Evidence of surcharge - Bench debris.

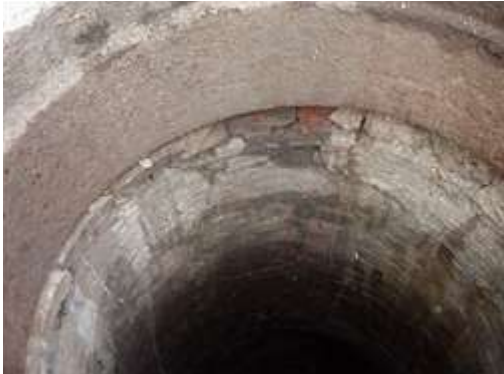
Defect

Frame leaks. Adjustment deterioration and infiltration. Corbel and Barrel infiltration.

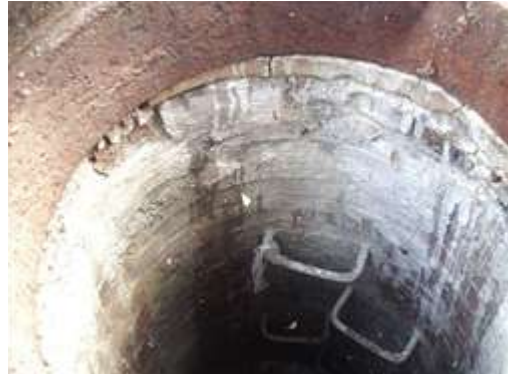
Defect

Frame leaks. Adjustment deterioration and infiltration. Corbel and Barrel infiltration.

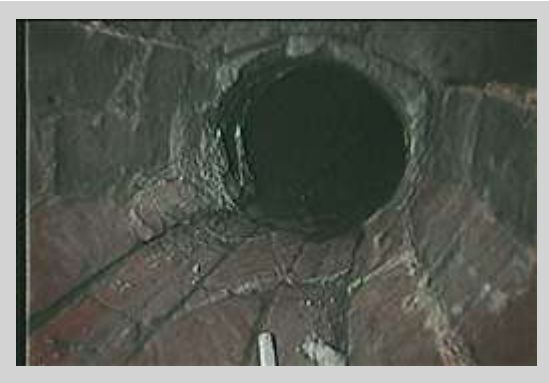
8 in. Circular Gravity Sewer Pipe Out @ 12 O'Clock

Channel deterioration.

Deposits: ☐ None ☐ Mud ☐ Sludge ☐ Debris ☒ Grease

Infiltration: **Evidence** Pipe Seal Cond: **Unknown**

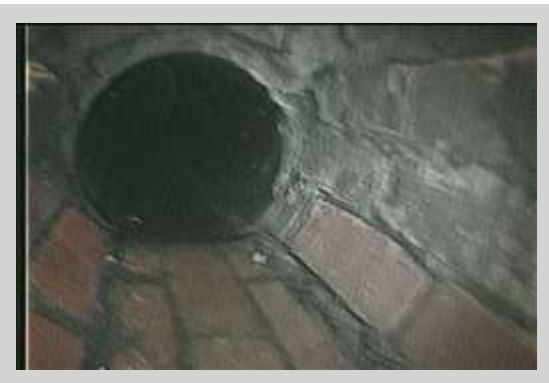
8 in. Circular Gravity Sewer Pipe In @ 4 O'Clock

Infiltration: **Evidence** Pipe Seal Cond: **Cracked**
